Water quality and ecological health of rivers in the Tokomairiro catchment

August 2011 - April 2012

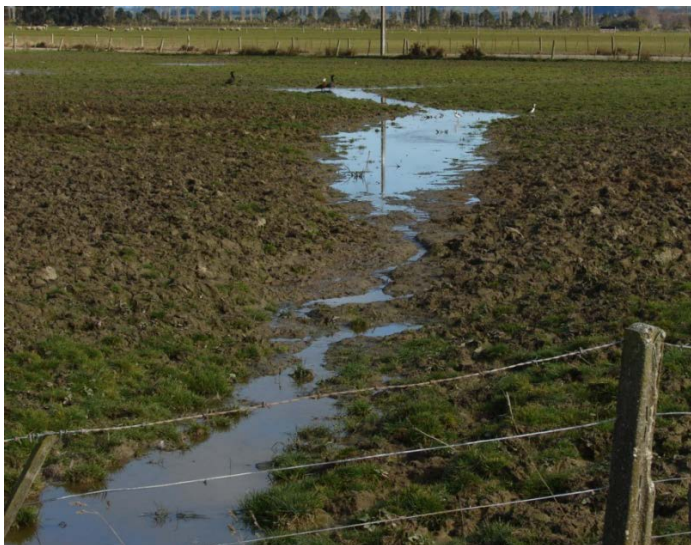
A pugged paddock that has an ephemeral stream flowing through it contributing sediment to the Tokomairiro River.

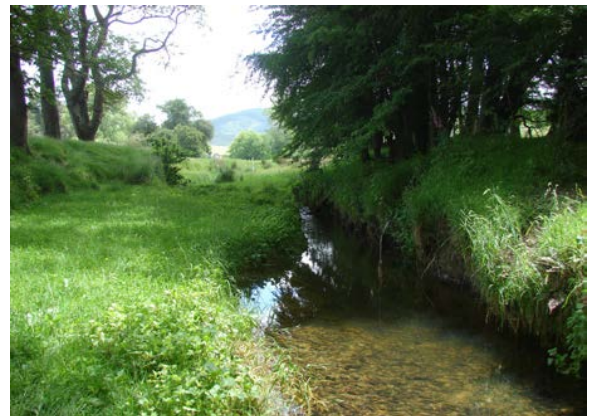
Falla Burn with stable banks

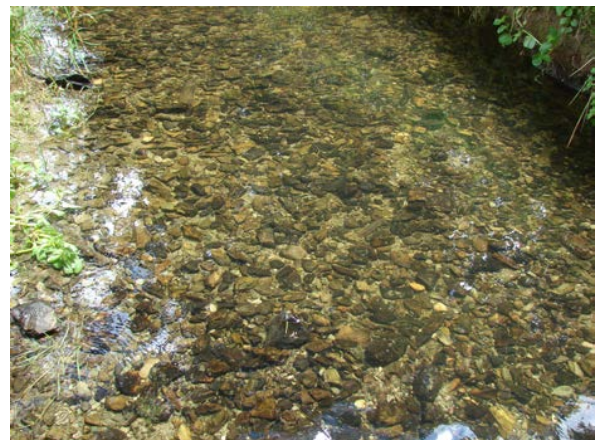
Coarse substrate in the Falla Burn

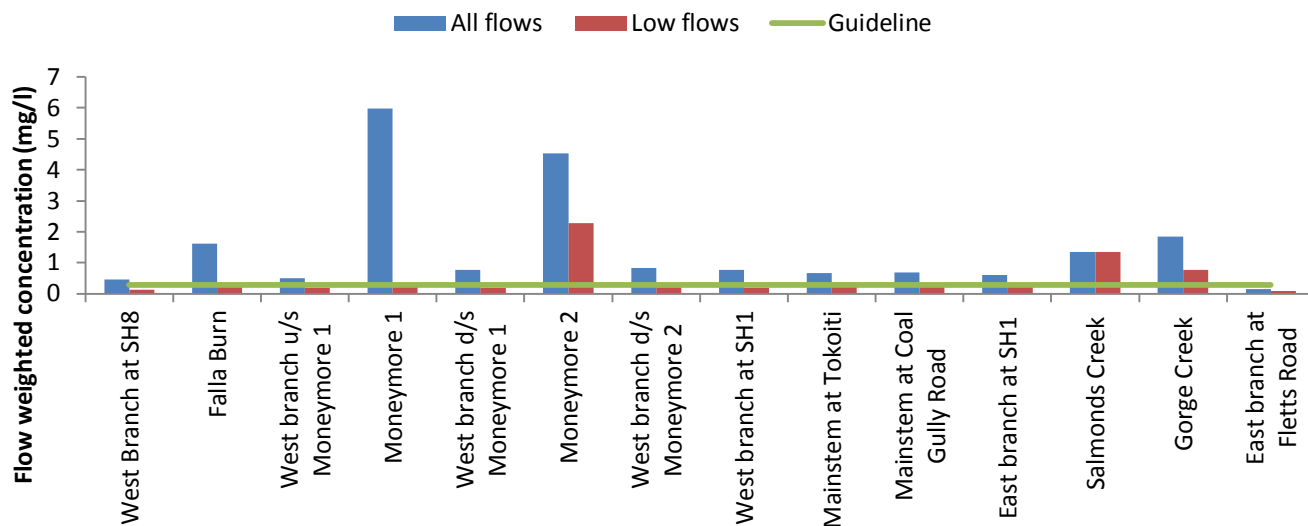
Flow weighted nitrite-nitrate-nitrogen concentrations for all sampling sites.

Sediment was elevated at the majority of sites for all flows. Bacteria counts were elevated at all sites and excessively high in the Moneymore drains. Nitrogen concentrations were elevated at all sites for the all flow category (except for the East Branch at Fletts Road) and most elevated in the Moneymore Drains.
